Missouri Schools for the Severely Disabled (MSSD) Educational Assessment/Study

Missouri Department of Elementary and Secondary Education

September 2024

Missouri Department of Elementary and Secondary Education
Educational Assessment/Study of the Missouri Schools for the Severely Disabled (MSSD)
September 2024

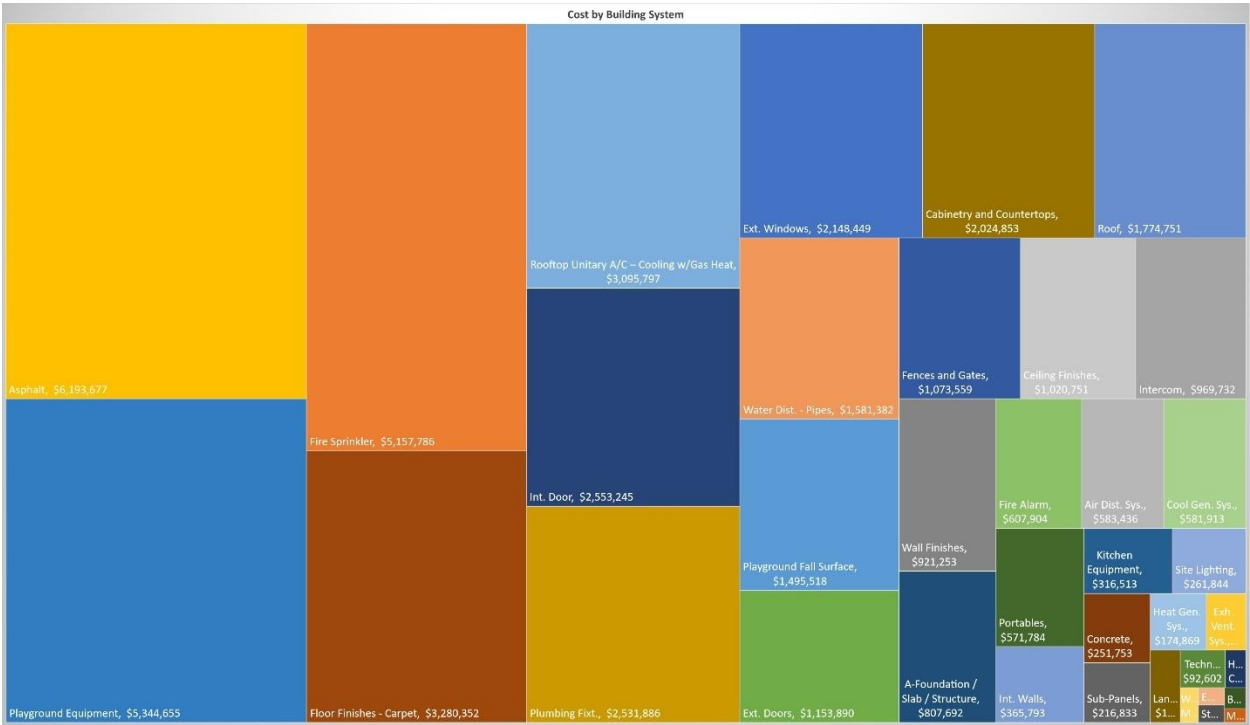
Exhibit 26. Tree Map Demonstrating Capital Needs by Building System

Although not immediately apparent, the HVAC systems represent approximately \$4M in capital needs and are generally a higher priority due to the severity of impact when failure occurs. HVAC systems are assessed in multiple building systems and these totals can be derived from the Rooftop Unitary A/C system, the Air Distribution System, the Heating Generation System, and the Cooling Generation System. Additional discussion on levels of priority can be found in the next section.

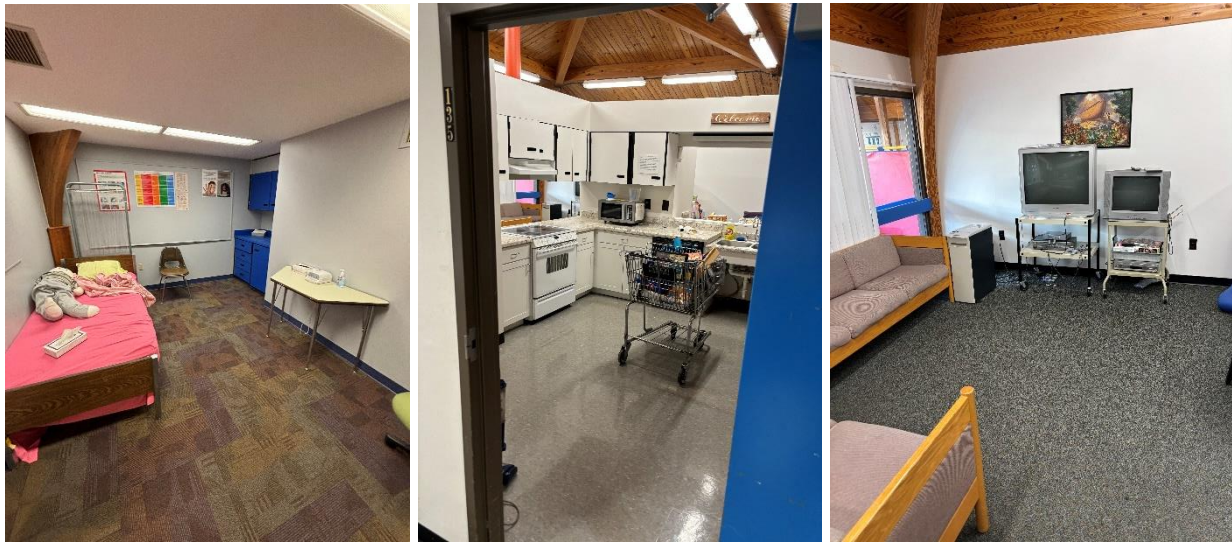
Exhibit 40. Photos of Home Living Classrooms and Mississippi Valley (left) and Parkview (central/right)

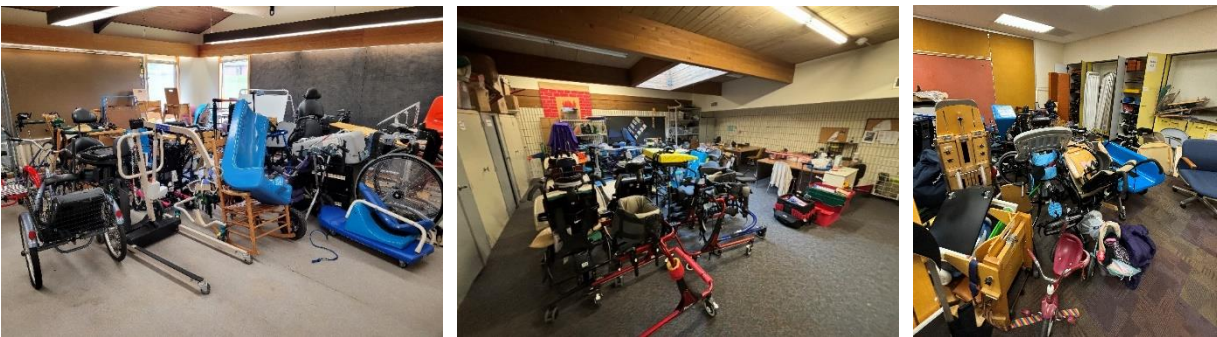
Exhibit 45. Photos of Classrooms Used for Excess Equipment Storage

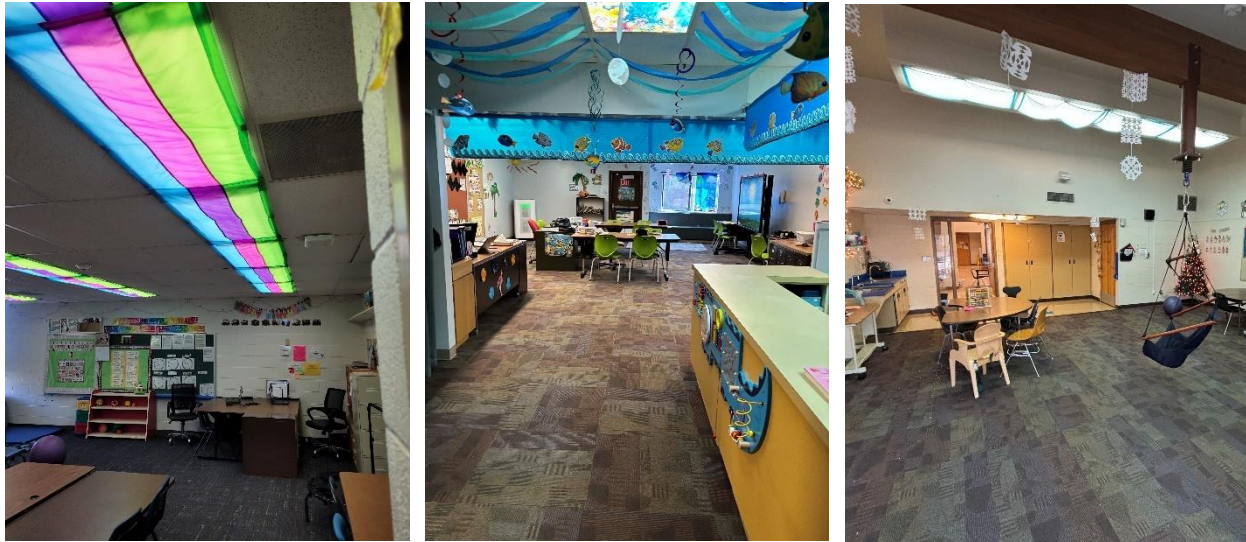
As discussed in the school condition section, OA-FMDC has invested properly in critical infrastructure building systems like roofs, HVAC, and fire alarms to ensure MSSD schools are protected and operational. Unfortunately, lighting has not been upgraded in many of the schools for decades and lacks modern controls and color tunability to serve students with disabilities. This has resulted in teachers installing homemade cloth covers over the fixtures to reduce the light output. Therefore, lighting scored second lowest of all educational adequacy categories, with wayfinding being the lowest in the assessment. Lighting can have a significant impact on student emotions, behavior, and outcomes and would be a good investment to increase educational adequacy. In addition to improving the quality of the indoor environment and student outcomes, upgrading lighting has a significant return on investment due to the energy savings for those that have not been upgraded to LED technology.

Exhibit 46. Photos of Lighting Fixtures With Covers to Reduce Light Output: Helen Davis (left), Shady Grove (center), E.W. Thompson (right)

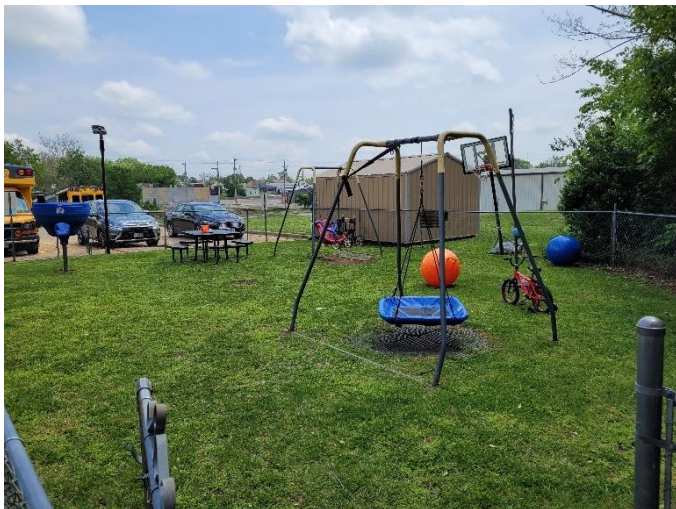
Exhibit 53. Photo of Skyview Playground

Many of the leased facilities playgrounds were inadequate from both a fall surface and equipment perspective. If fall surfaces were present, they were made of rubber tiles that are failing across many MSSD schools. These present trip hazards and large gaps that the wheelchairs get stuck in according to staff.

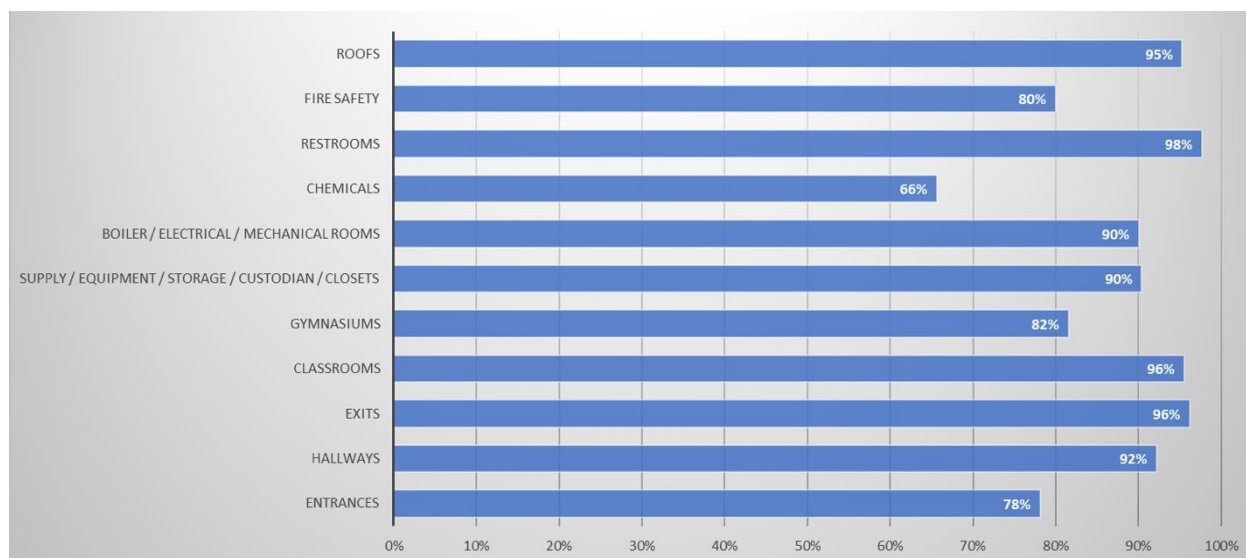
Exhibit 59. Level of Facilities Maintenance from a Categorical Perspective

As discussed in the school condition section, OA-FMDC has invested properly in critical infrastructure such as roofs, HVAC, and fire alarms to ensure MSSD schools are protected and operational. Roofs scored 95% on the facilities maintenance assessment. These scores are evidence of the findings that OA-FMDC's investment in the roofing systems is adequate.

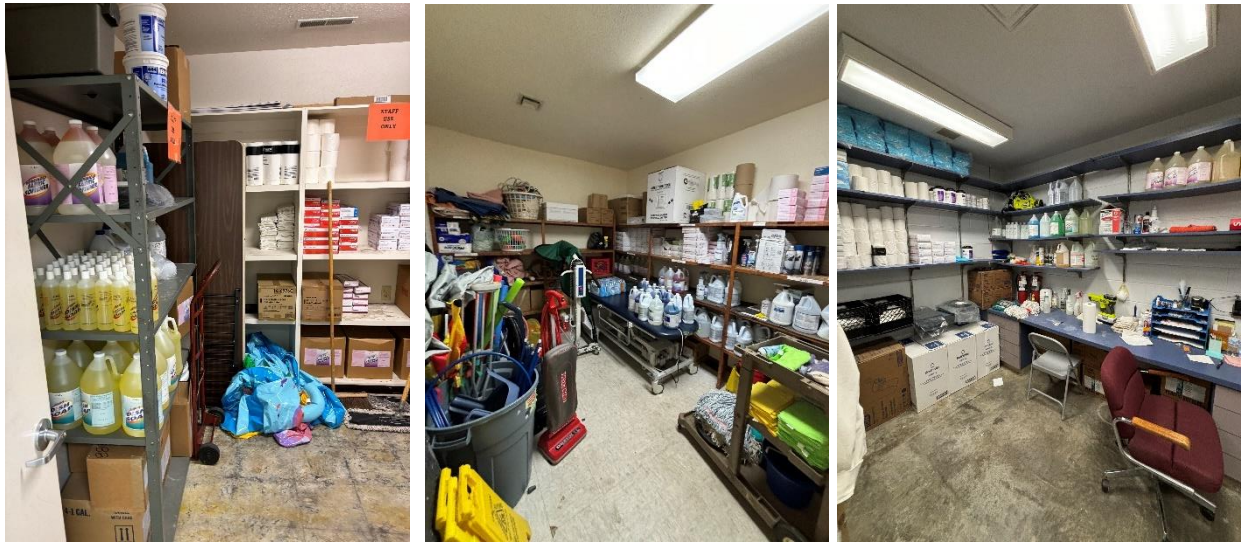
Alternatively, the chemicals category scored the lowest across the MSSD portfolio. Proper chemical management ranged from very well to poor. It was observed in several schools that chemicals are being stored in unlabeled containers; occasionally in closets that are unlocked. Maintaining Safety Data Sheets at each site was appropriate, yet chemical disposal methods are non-existent. As a result, schools are storing chemicals that are beyond expiration dates and are no longer usable. For example, one school has laundry detergent that has been on the shelves for so long that the solids have completely separated from the liquid. Subsequently, the school has been purchasing new laundry detergent and left the expired products on the shelf.

Exhibit 60. Photos of Chemical Storage at Ozark Hills (left), Ozark Horizon (center), and Prairie View (right)

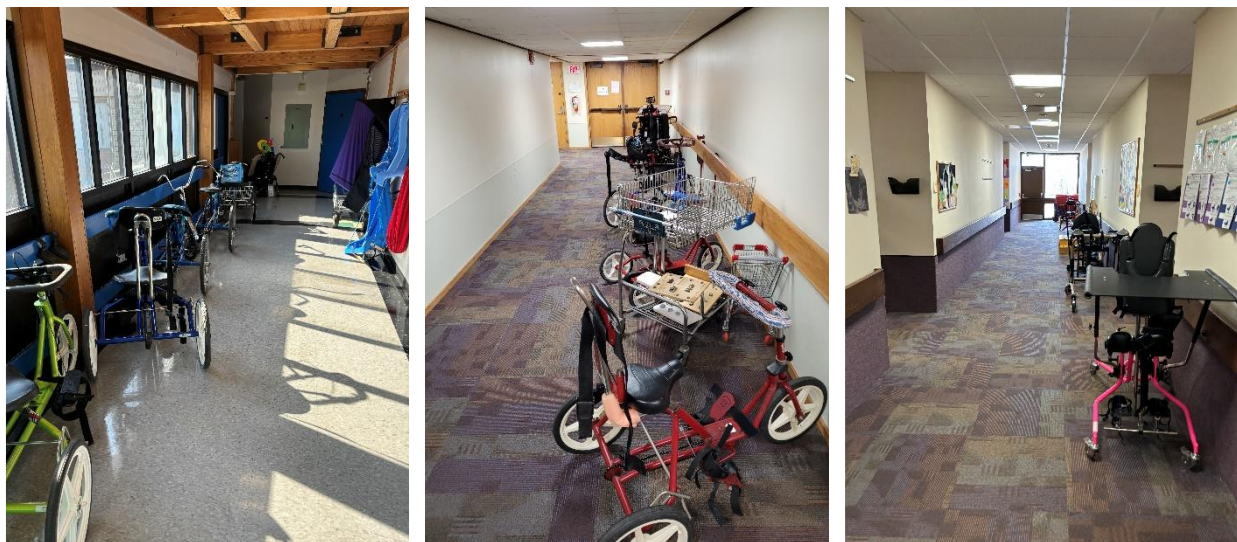
Exhibit 69. Photos of Egress Routes with Equipment Storage: Parkview, Greene Valley, and Mapaville (left to right)
